Restoring and Enhancing Historic Property

By Dr. JoAnne Castagna

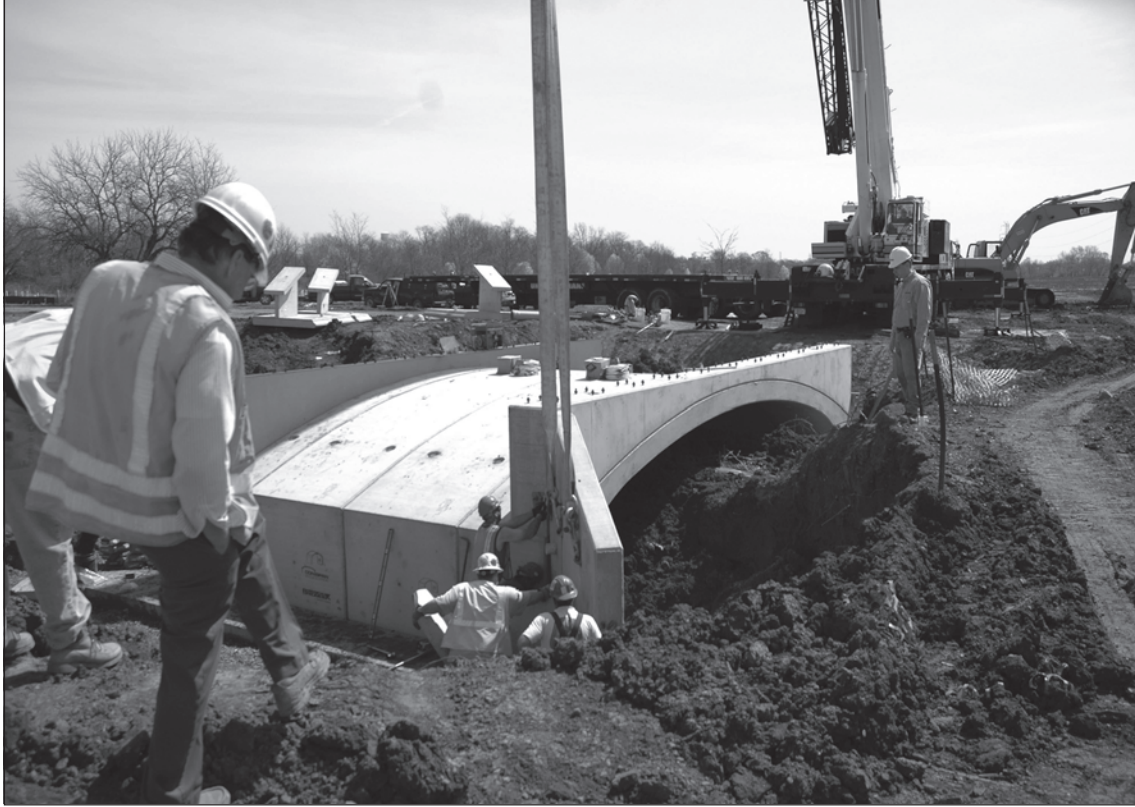
A multisection precast concrete bridge is lowered by crane across a stream.

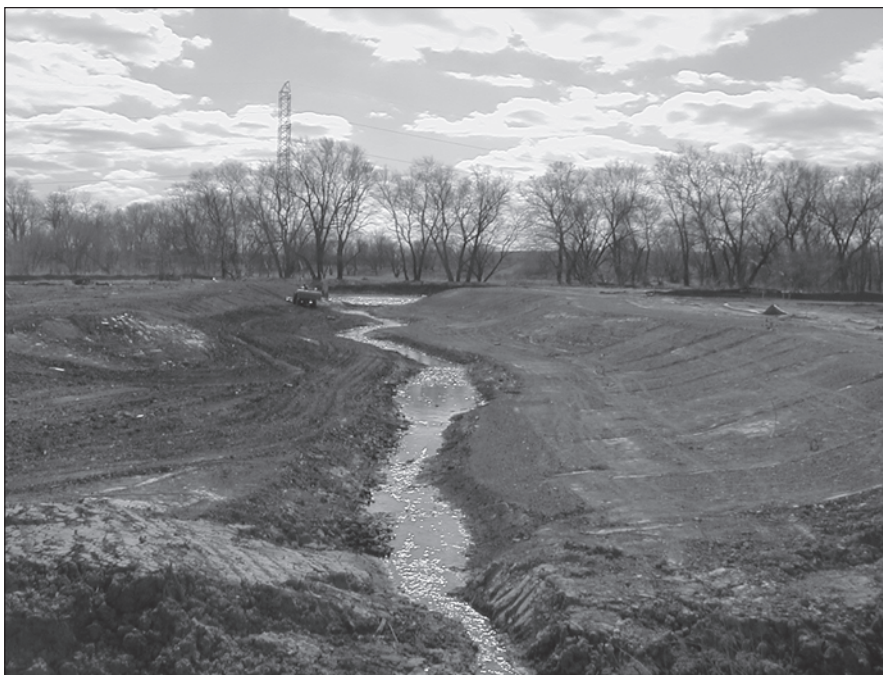
The banks of the "Finderne Brook"—that flows into the Raritan River—have been contoured to prepare for planting.

Stream Restoration. An unnamed 800-foot stream, referred to as the "Finderne Brook," runs through portions of the site. The stream was eroding and the Corps created a more natural water flow and restored its habitat. To improve the water flow, the area bordering the stream (the floodplain) was widened to prevent the stream's banks from eroding and an undersized pipe culvert, that was constricting flow, was replaced with a natural bottom arched culvert bridge. To improve the stream habitat and stabilize the banks, the stream was graded, seeded with floodplain grass, planted with wetland plant cuttings, and covered with a degradable coir matting (made of coconut fiber) to stabilize riverbank soils until the vegetation takes hold. To prevent soil erosion, supplemental riverbed stone was placed in the stream. Also, the stones create a series of pools and riffles for fish and invertebrate habitats such as crayfish and pickerel frogs that have already been sighted in the stream.

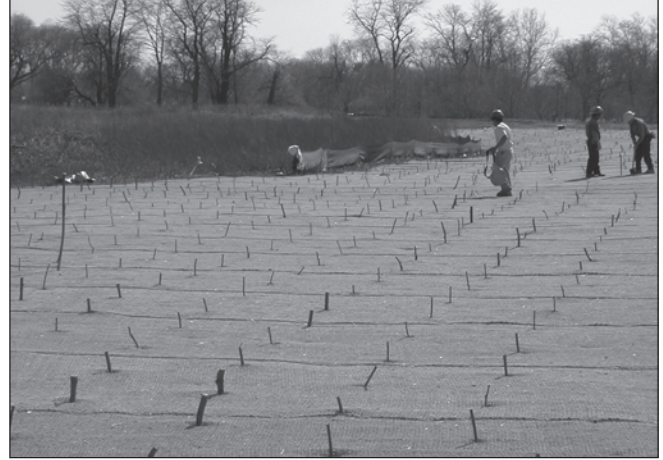
Thousands of "willow stakes" are planted in burlap weed barriers along the side of the stream.
